INVESTIGATION OF HYDROTEST FAILURE OF THIOKOL CHEMICAL
CORPORATION 260-INCH-DIAMETER SL-1 MOTOR CASE

By John E. Srawley and Jack B. Esgar

Lewis Research Center
Cleveland, Ohio

in Collaboration with the
260-SL-1 Hydrotest Failure Investigating Committee

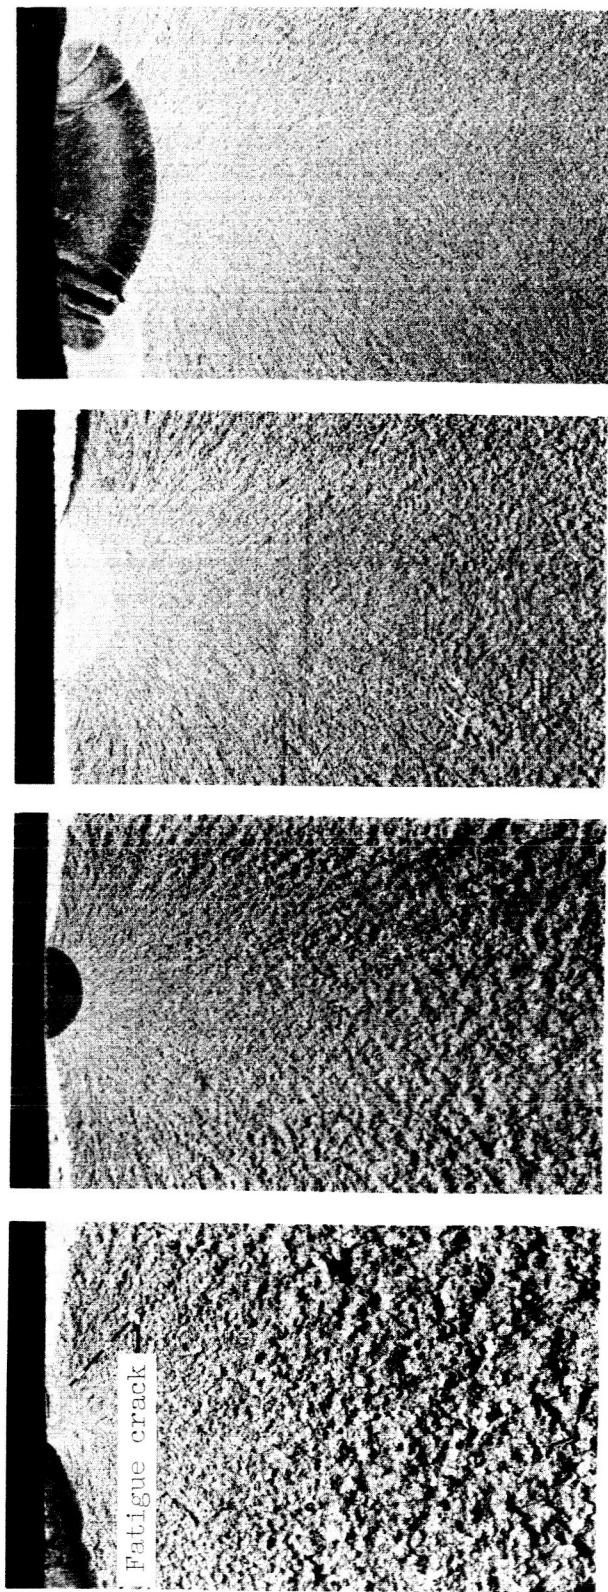
Specimen:	B	C	D	E
Fatigue crack depth, in.:	0.030	0.041	0.063	0.106
Fatigue crack surface length, in.:	0.075	0.100	0.155	0.309
Thickness, in.:	0.743	0.747	0.713	0.737

Figure 18. - Fatigue cracks in test plates for nondestructive inspection evaluation program. x5.
(Specimen A had no fatigue cracks.)

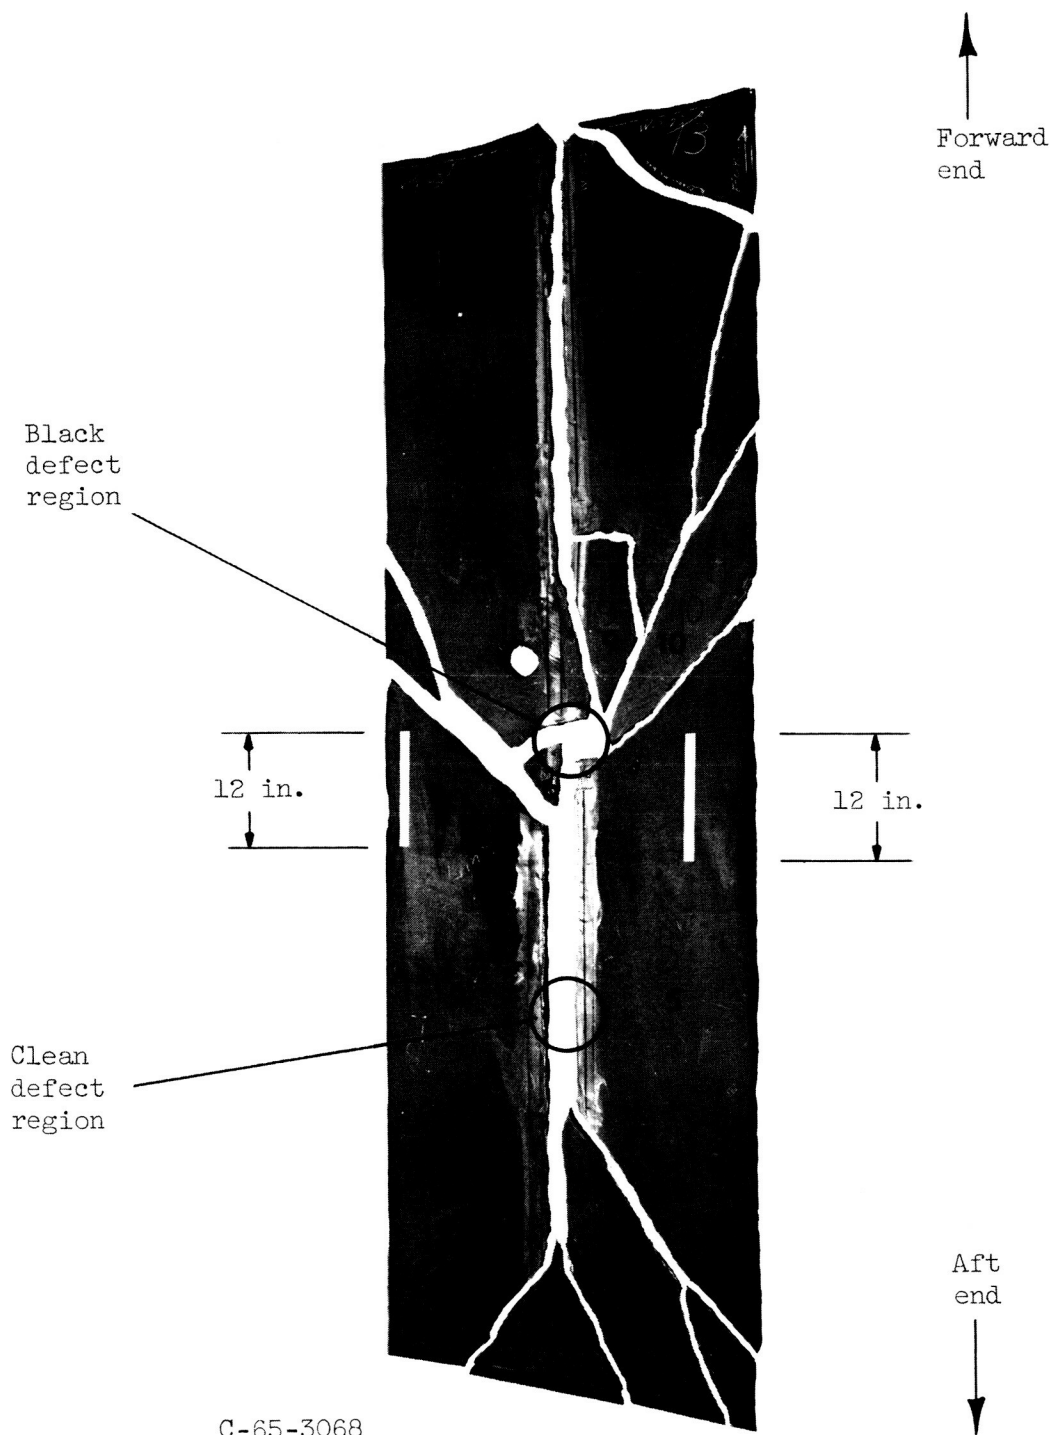
Figure 19. - Plan view of fracture paths (inside surface of motor case shown).

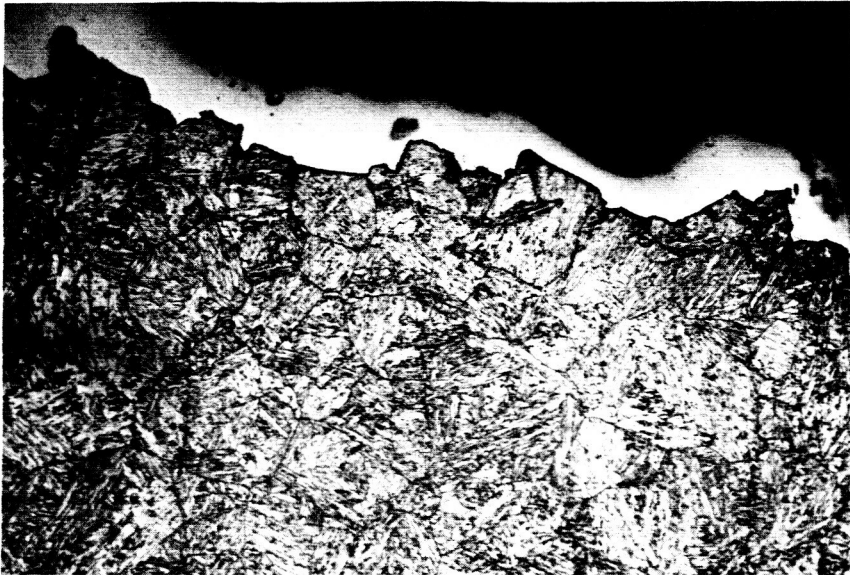
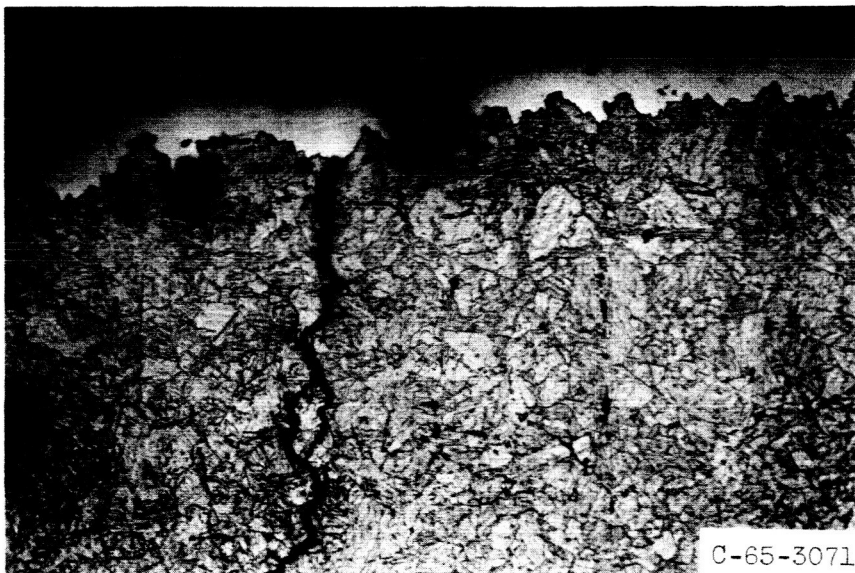
(a) Area 1.

(b) Area 2.

Figure 21. - Fracture profiles of clean defect region
(section B-B of fig. 20(a)). Nital etchant. X200.

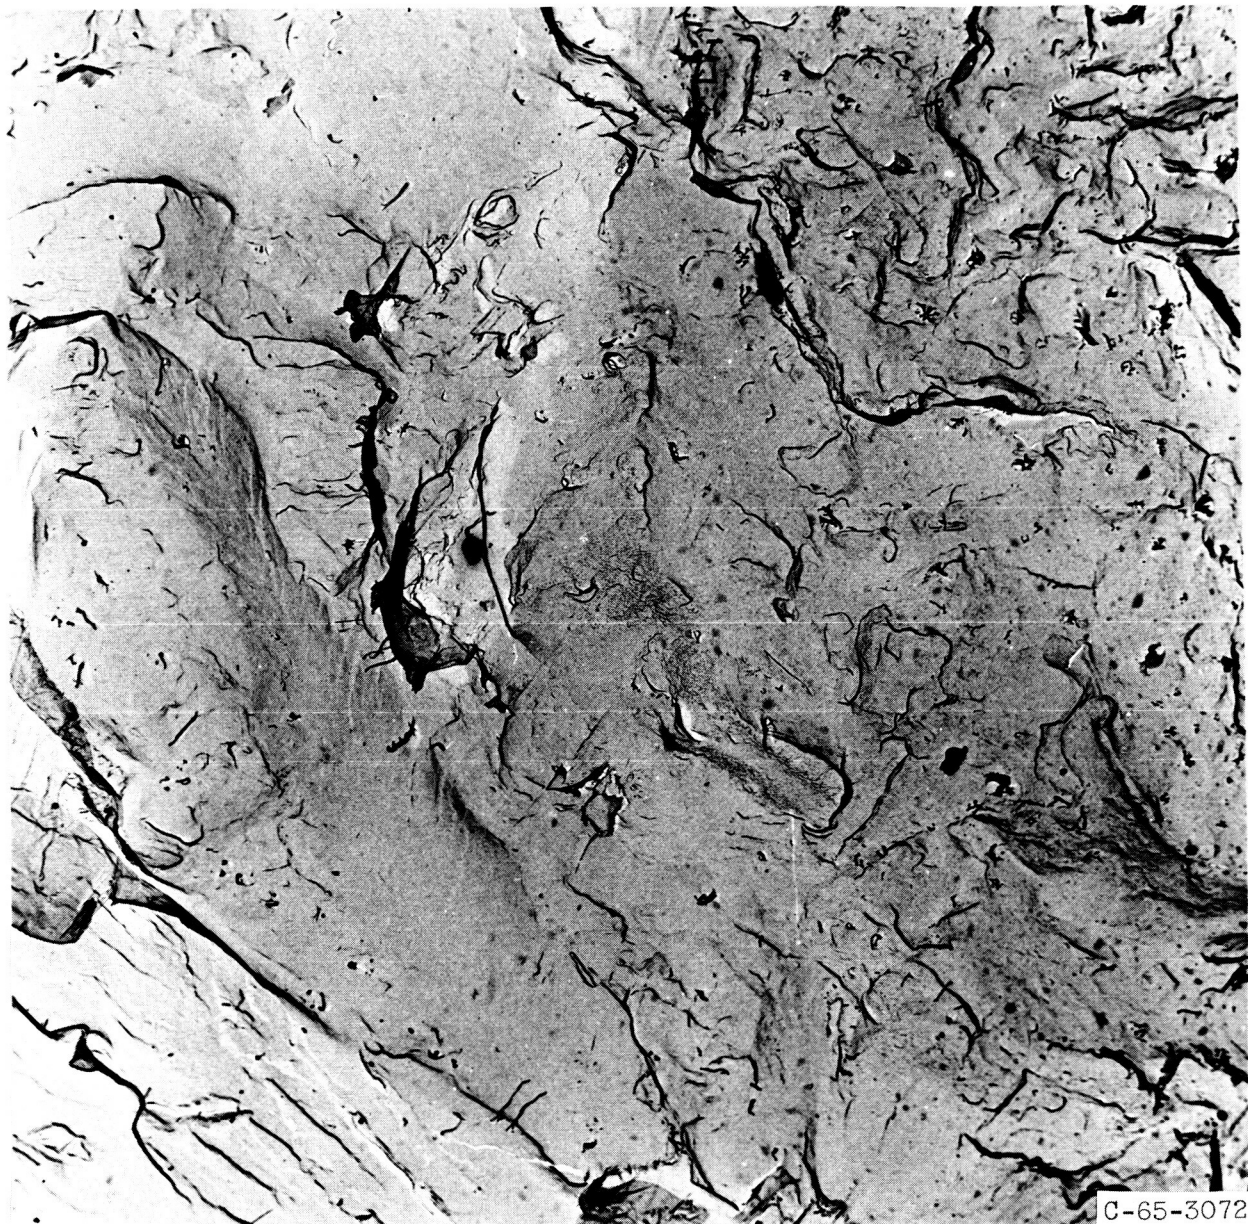
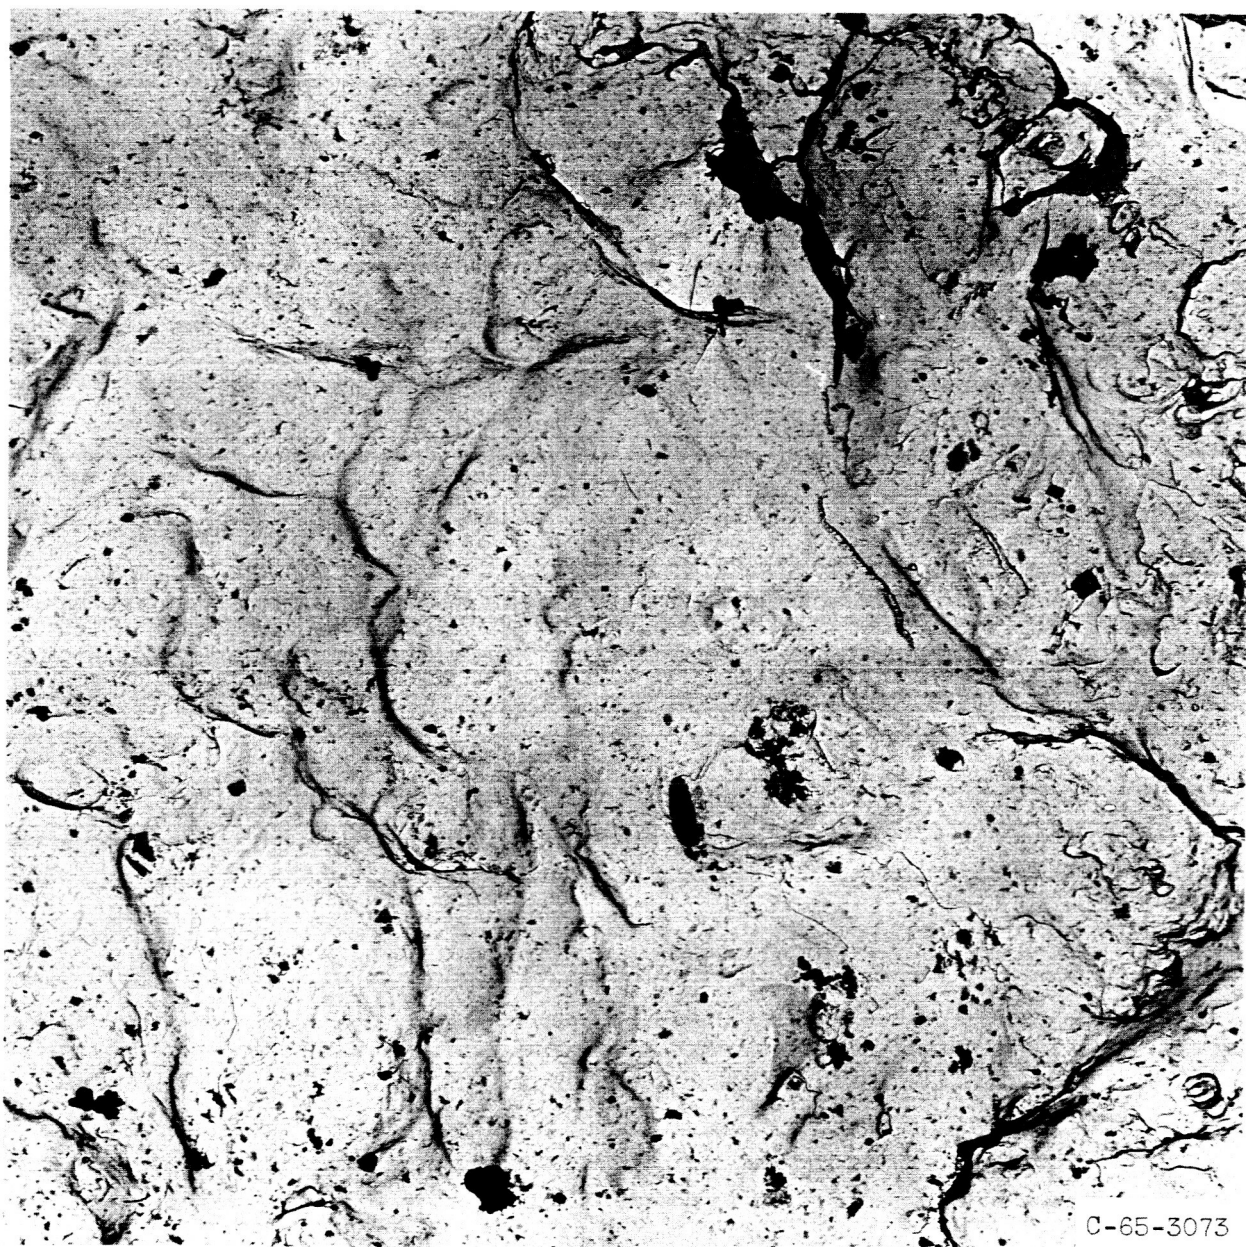
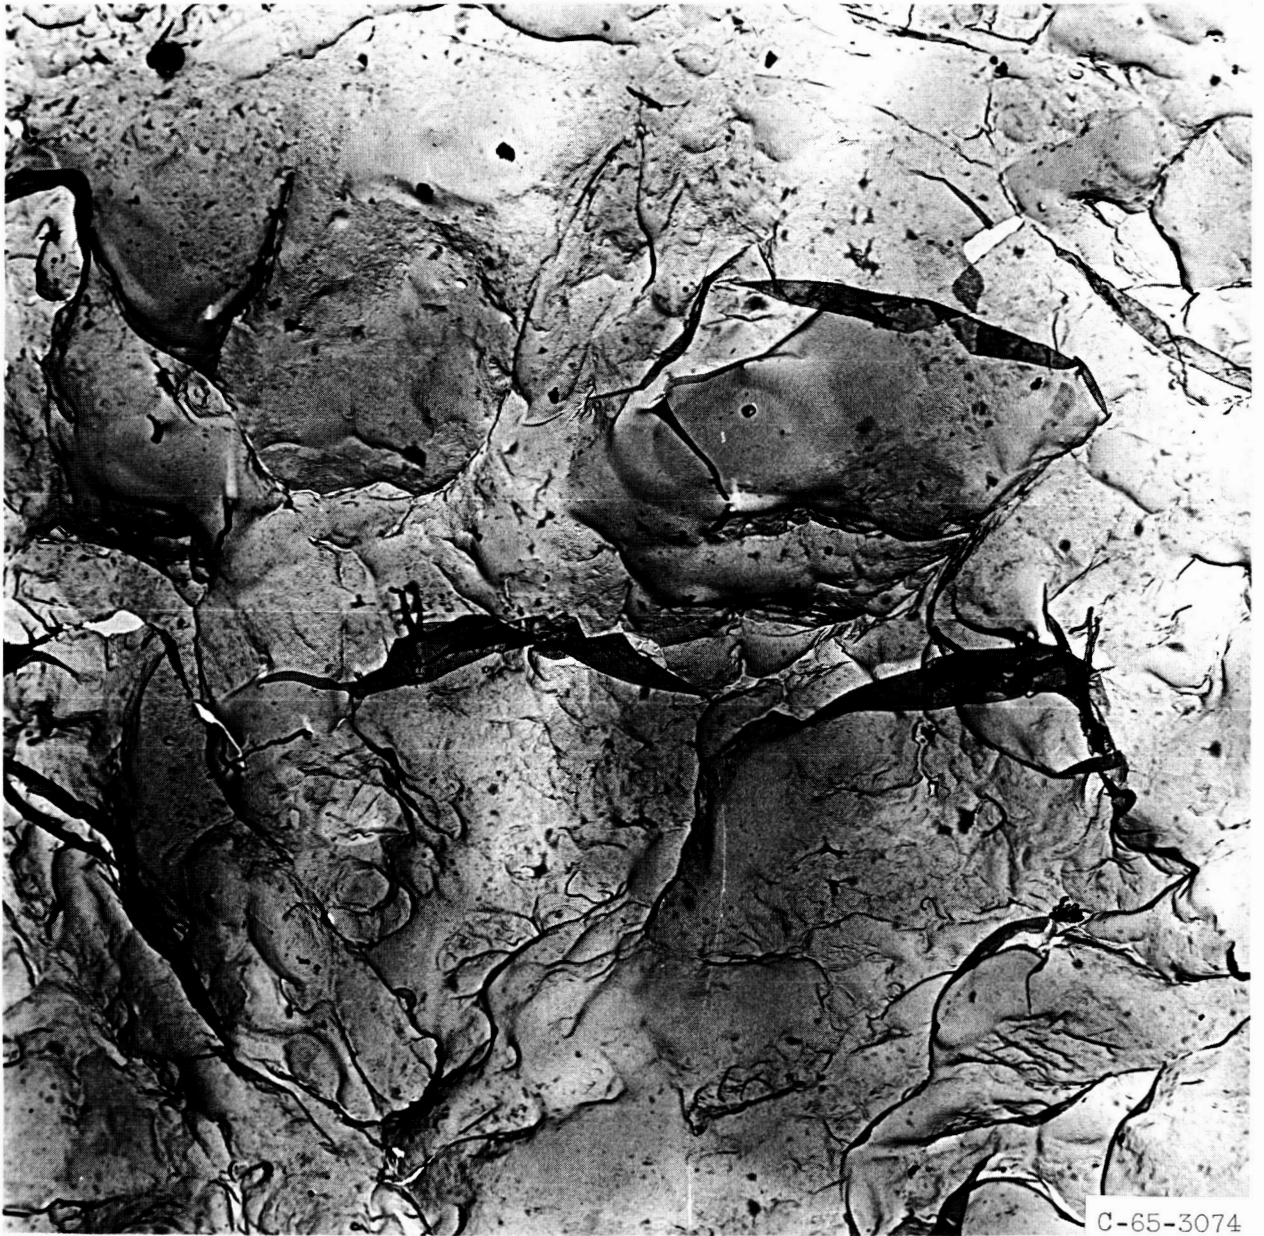
(a) Area 1 of figure 20 (b).

Figure 22. - Fractograph of clean defect. x5000.

(b) Weld metal - area 2 of figure 20 (b).

(c) Base plate - area 3 of figure 20(b).

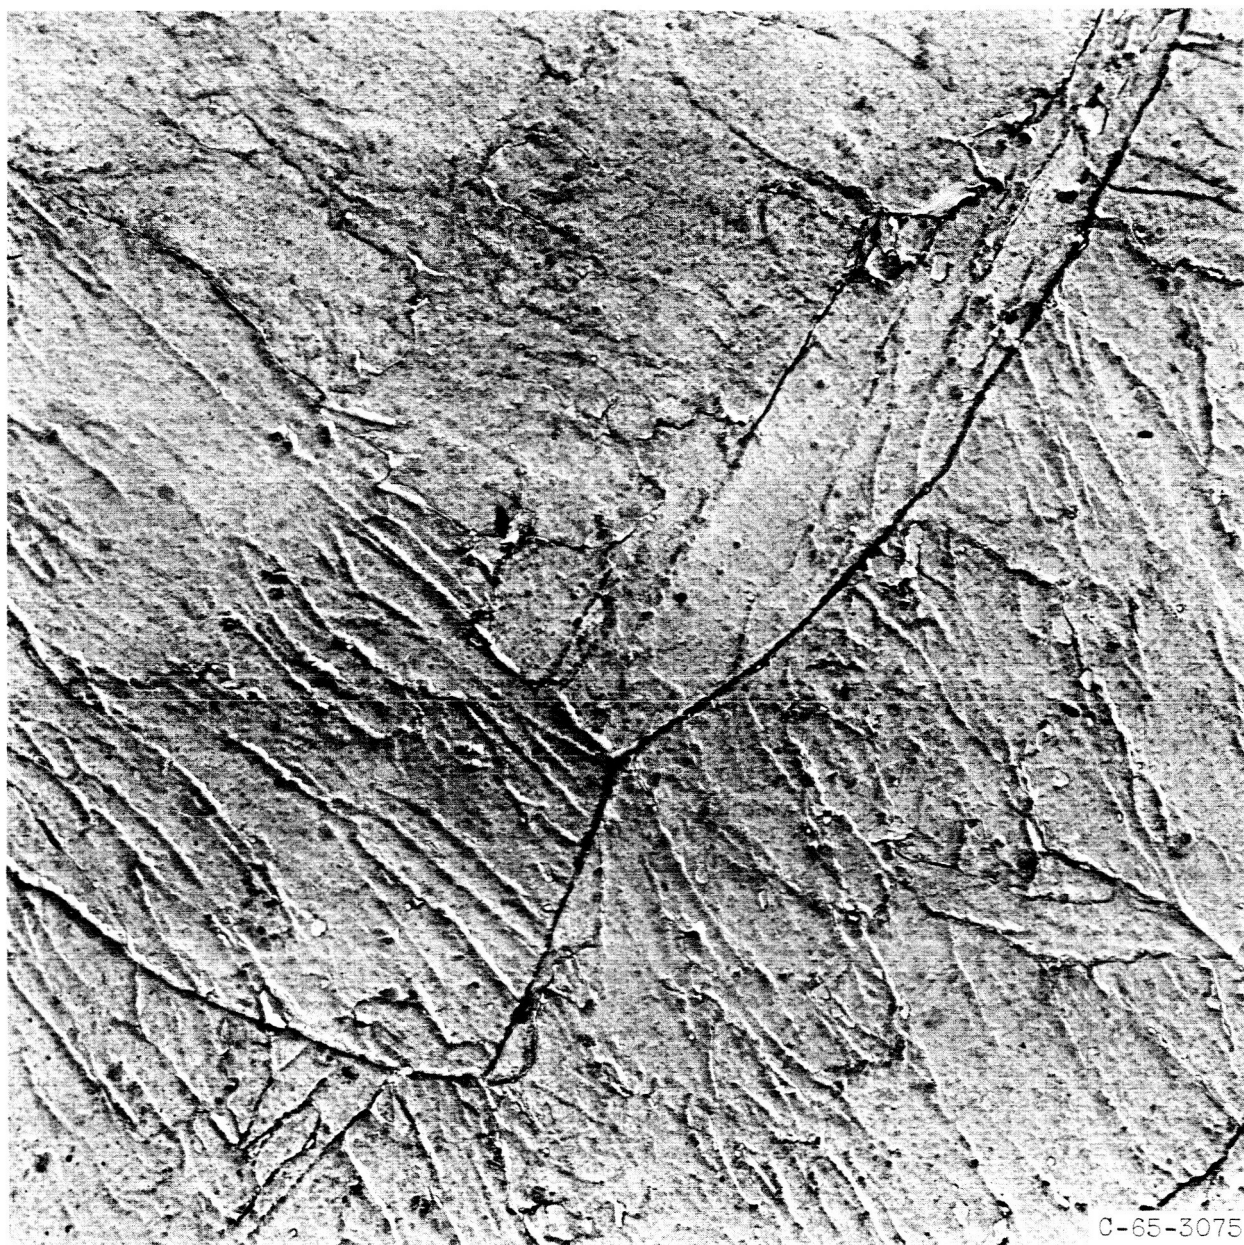
Figure 23. - Replication electron micrograph of area near clean defect.
x12 000.

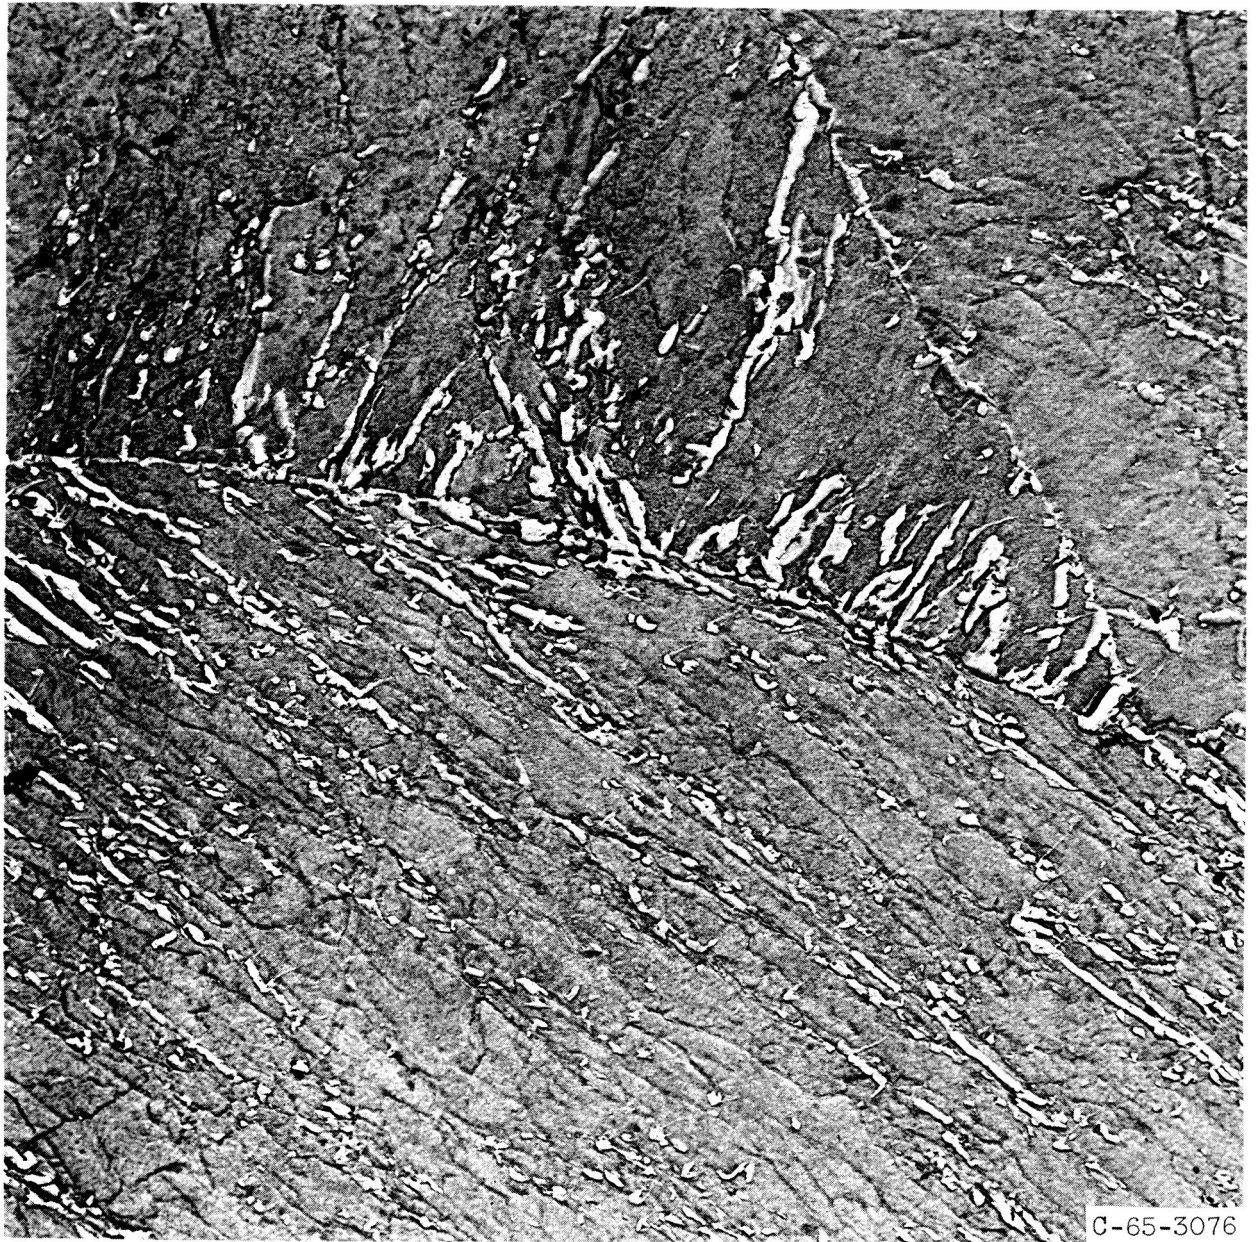
Figure 24. - Replication electron micrograph of region of base plate near subarc weld fusion zone in clean defect region. $\times 10\ 000$.

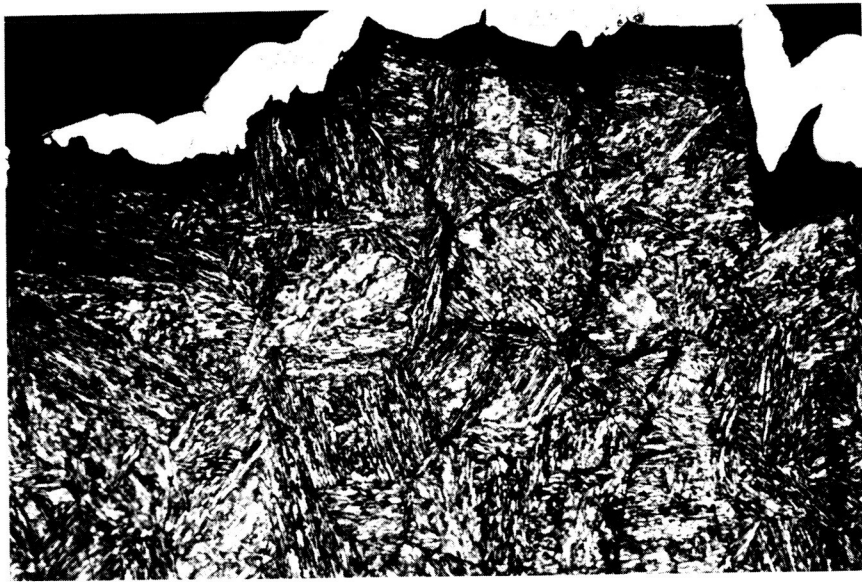
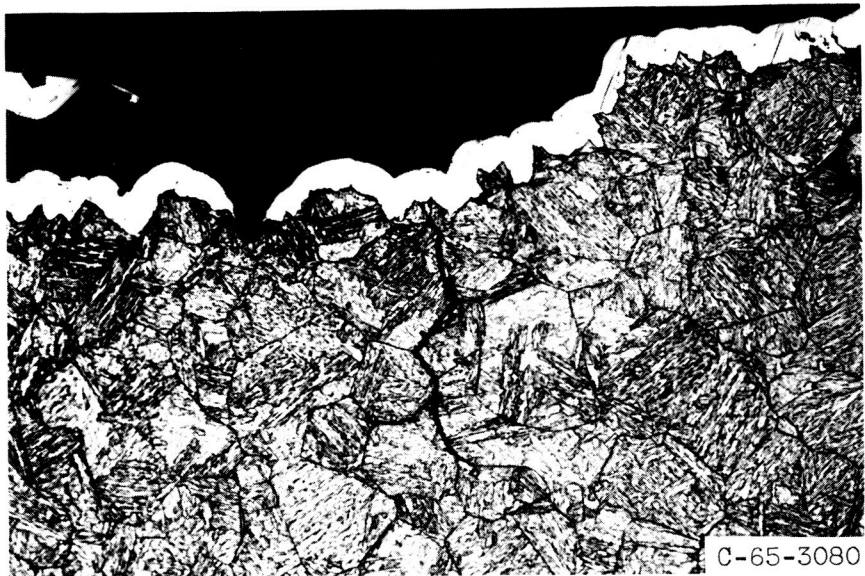
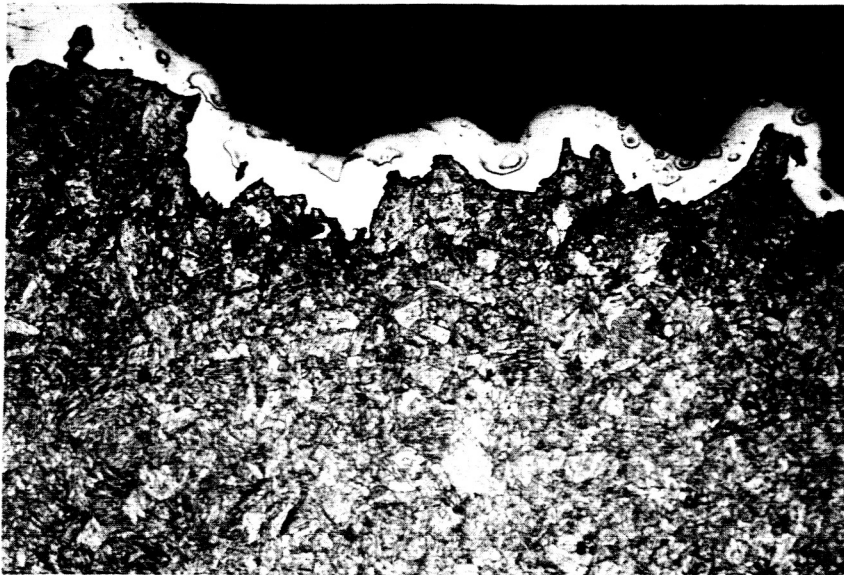
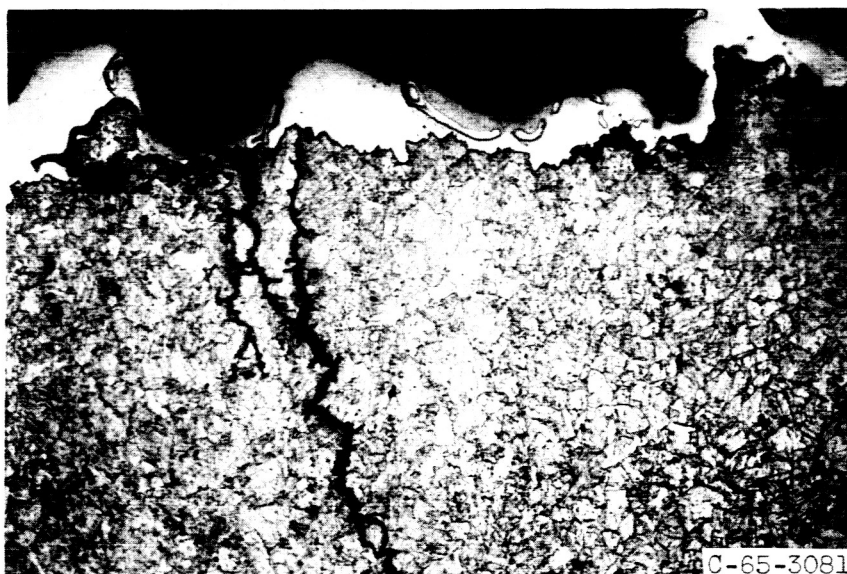
Figure 28 shows fracture profiles through the black-defect surface. The black layer between the steel and the nickel plate in figure 28(a) is a plastic mounting compound that seeped under the loose nickel coating during metallographic mounting. Figures 28(a) and (b), which were taken from section E-E in figure 27, show the profile of the grain-coarsened base plate in the region of the subarc weld HAZ. Figures 28(c) and (d), which were taken from section D-D in figure 27, show a region of base plate outside the subarc weld HAZ.

(a) Black defect (from area 1, section E-E, fig. 27).

(b) Away from black defect (base plate, from area 2, section E-E, fig. 27).

Figure 28. - Fracture profiles of black defect region.
Nital etchant. $\times 200$.

(c) From area 1 (section D-D, fig. 27).

(d) From area 2 (section D-D, fig. 27).

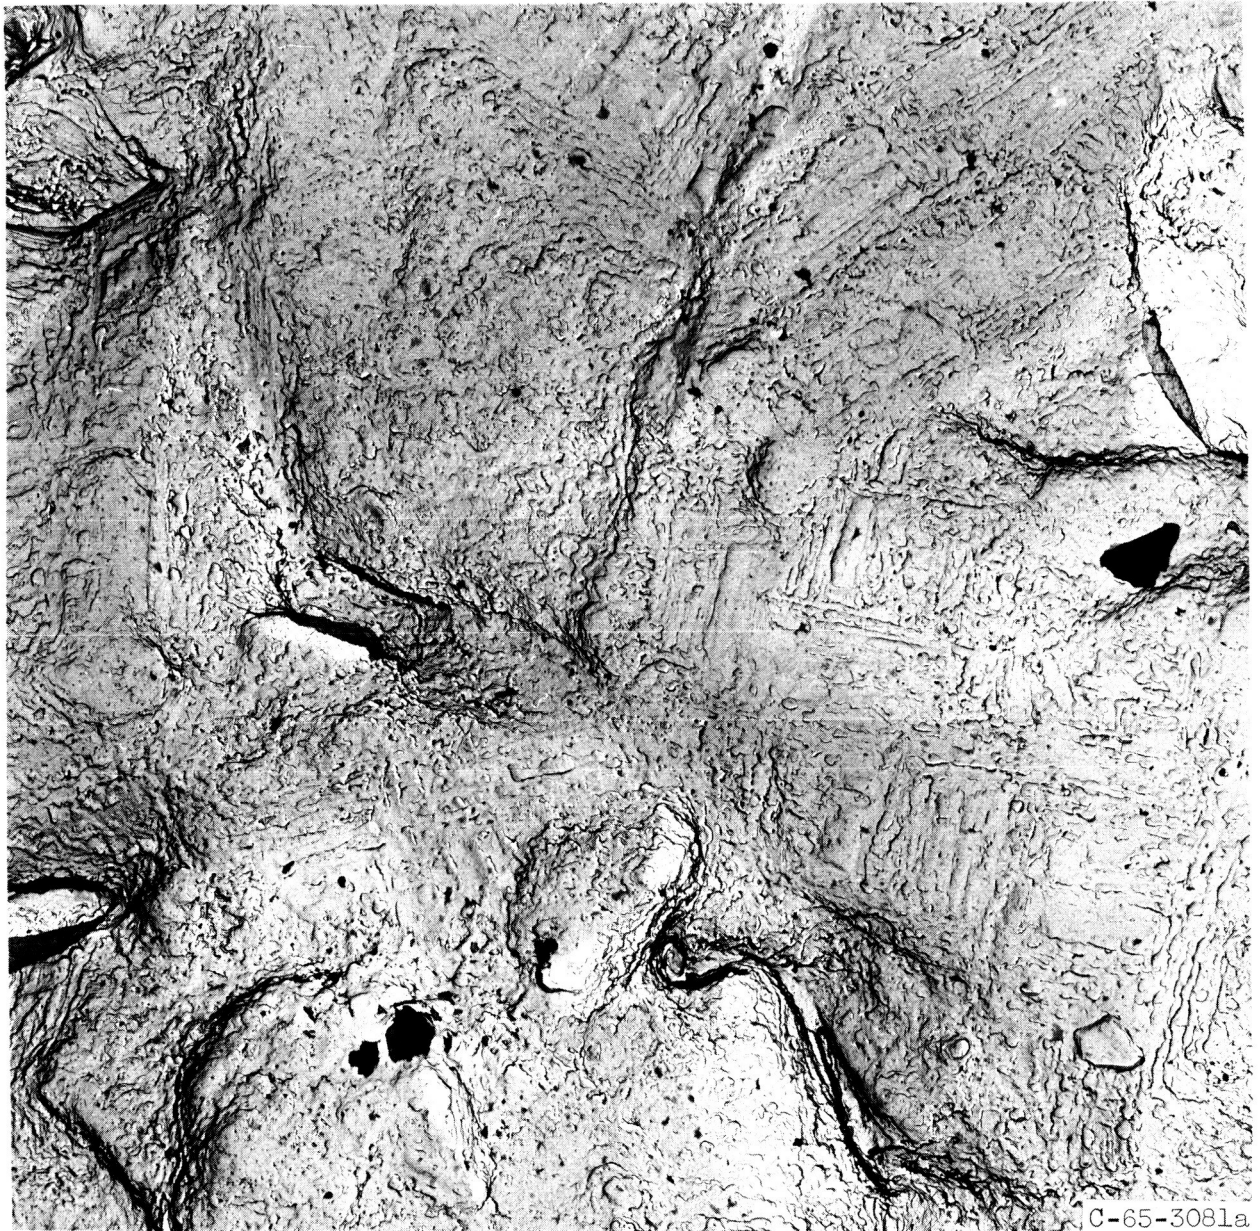
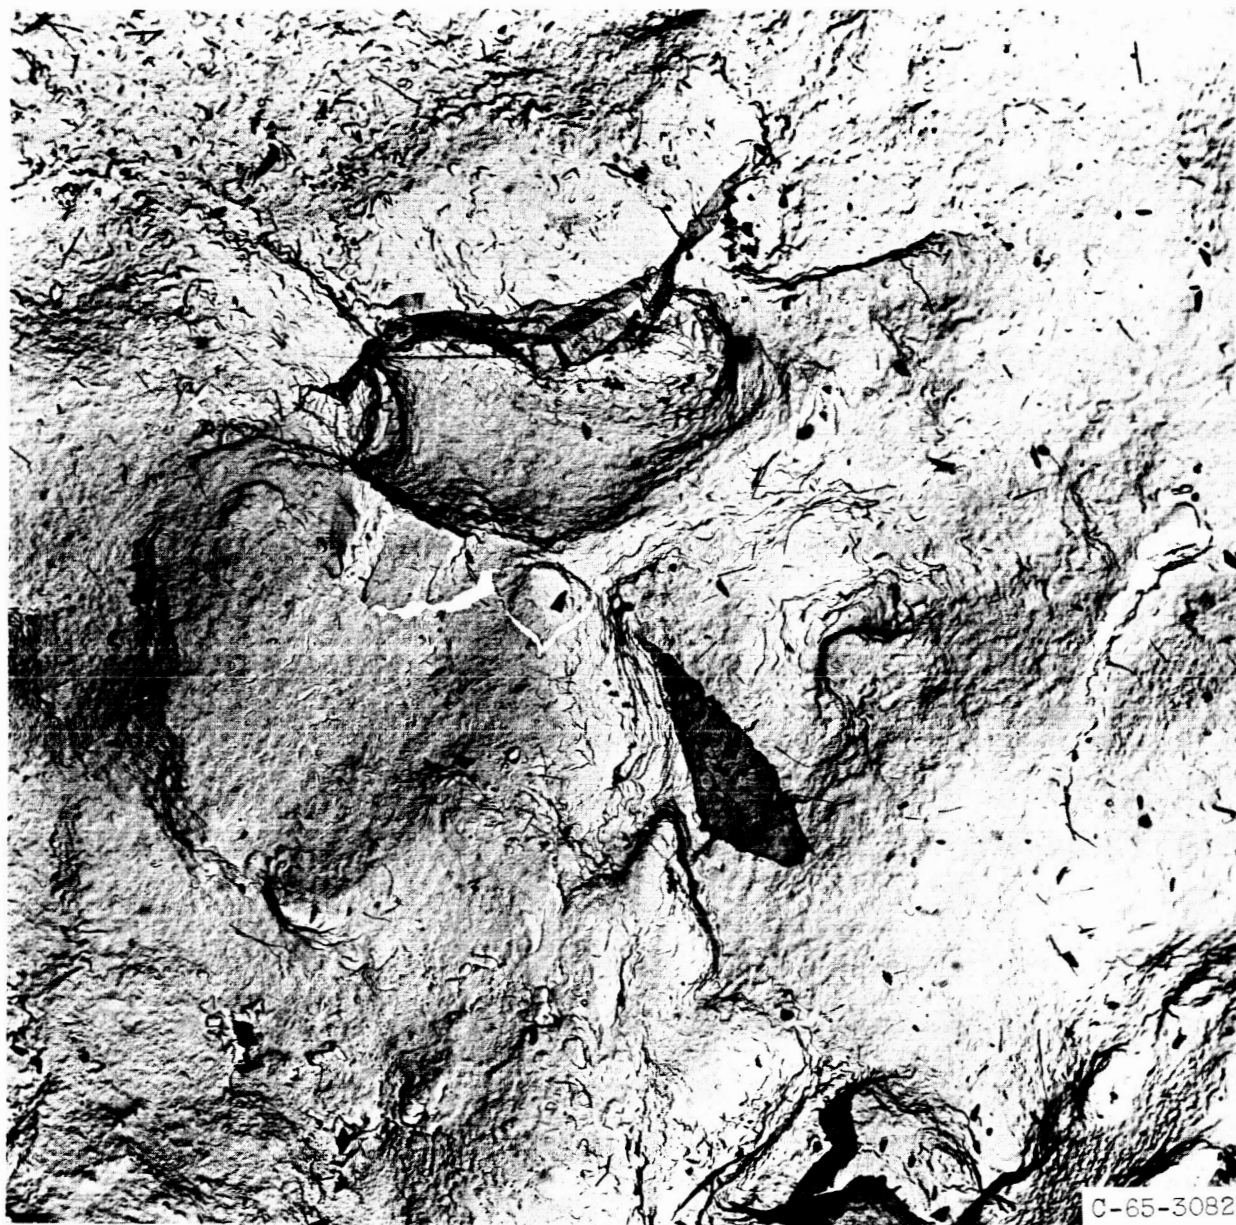
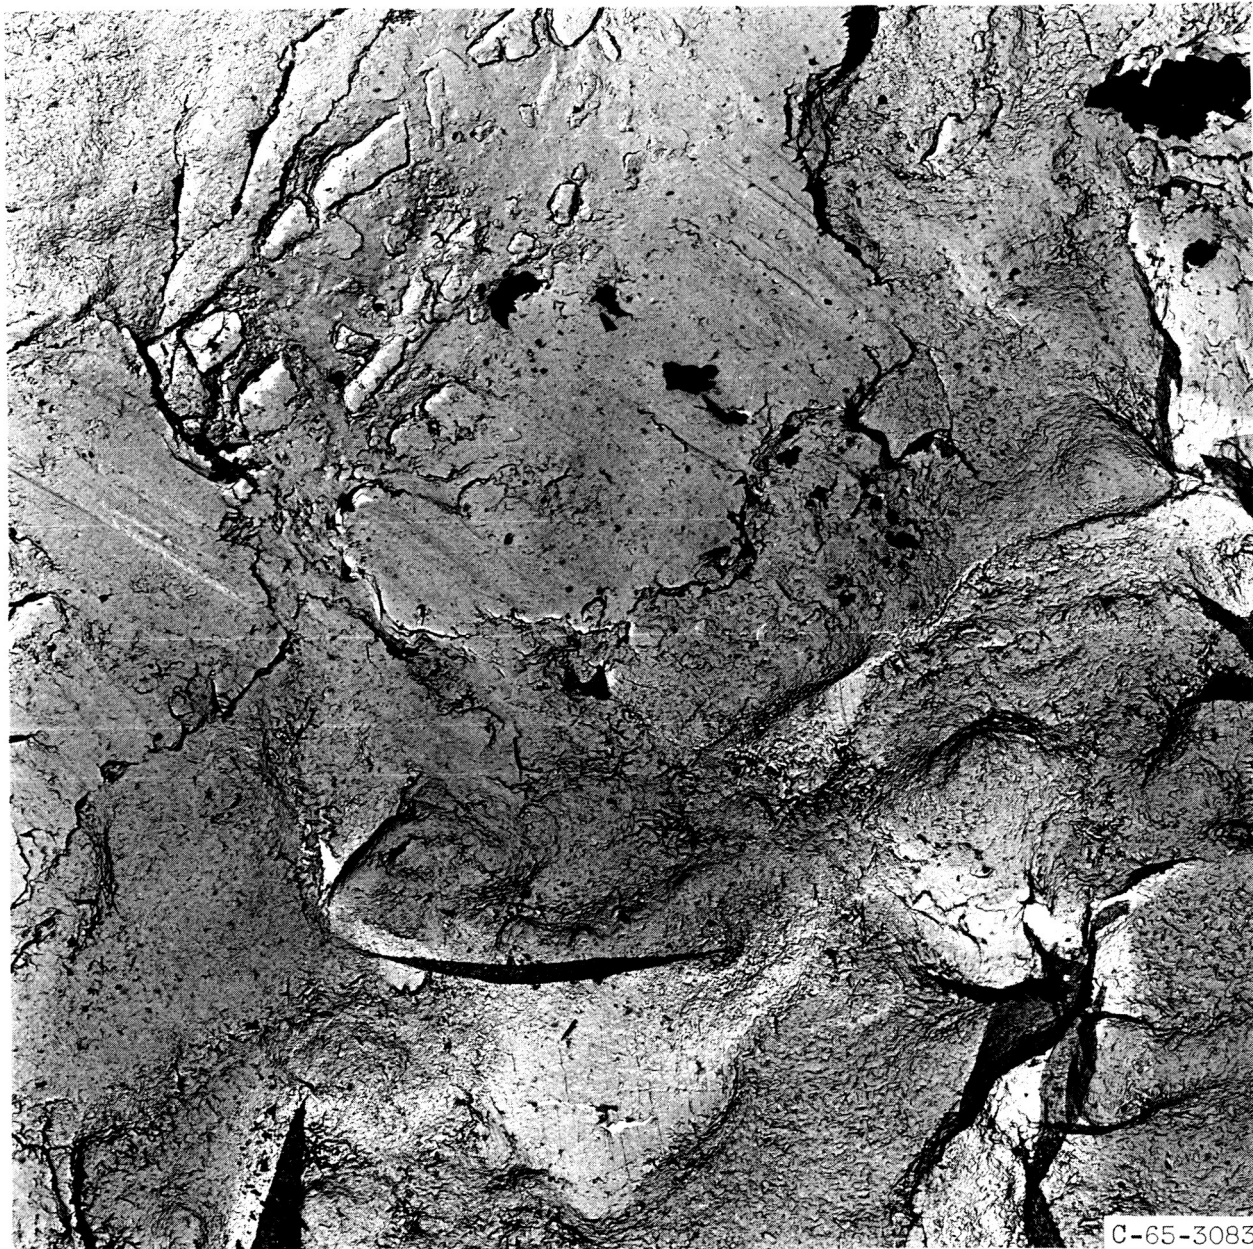
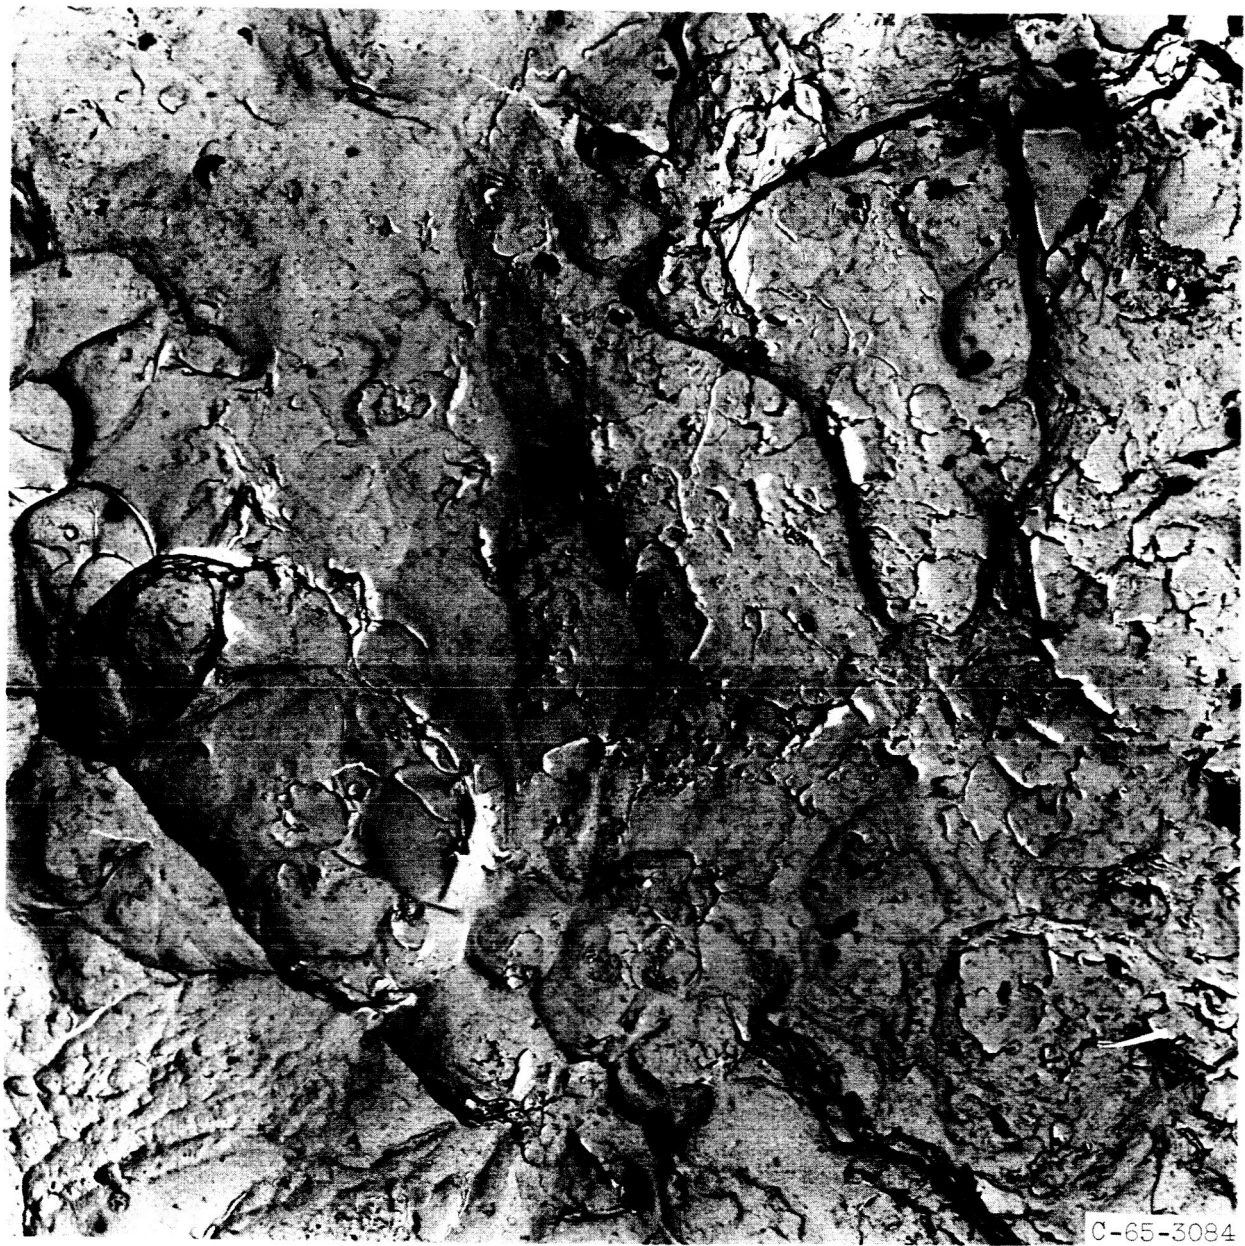
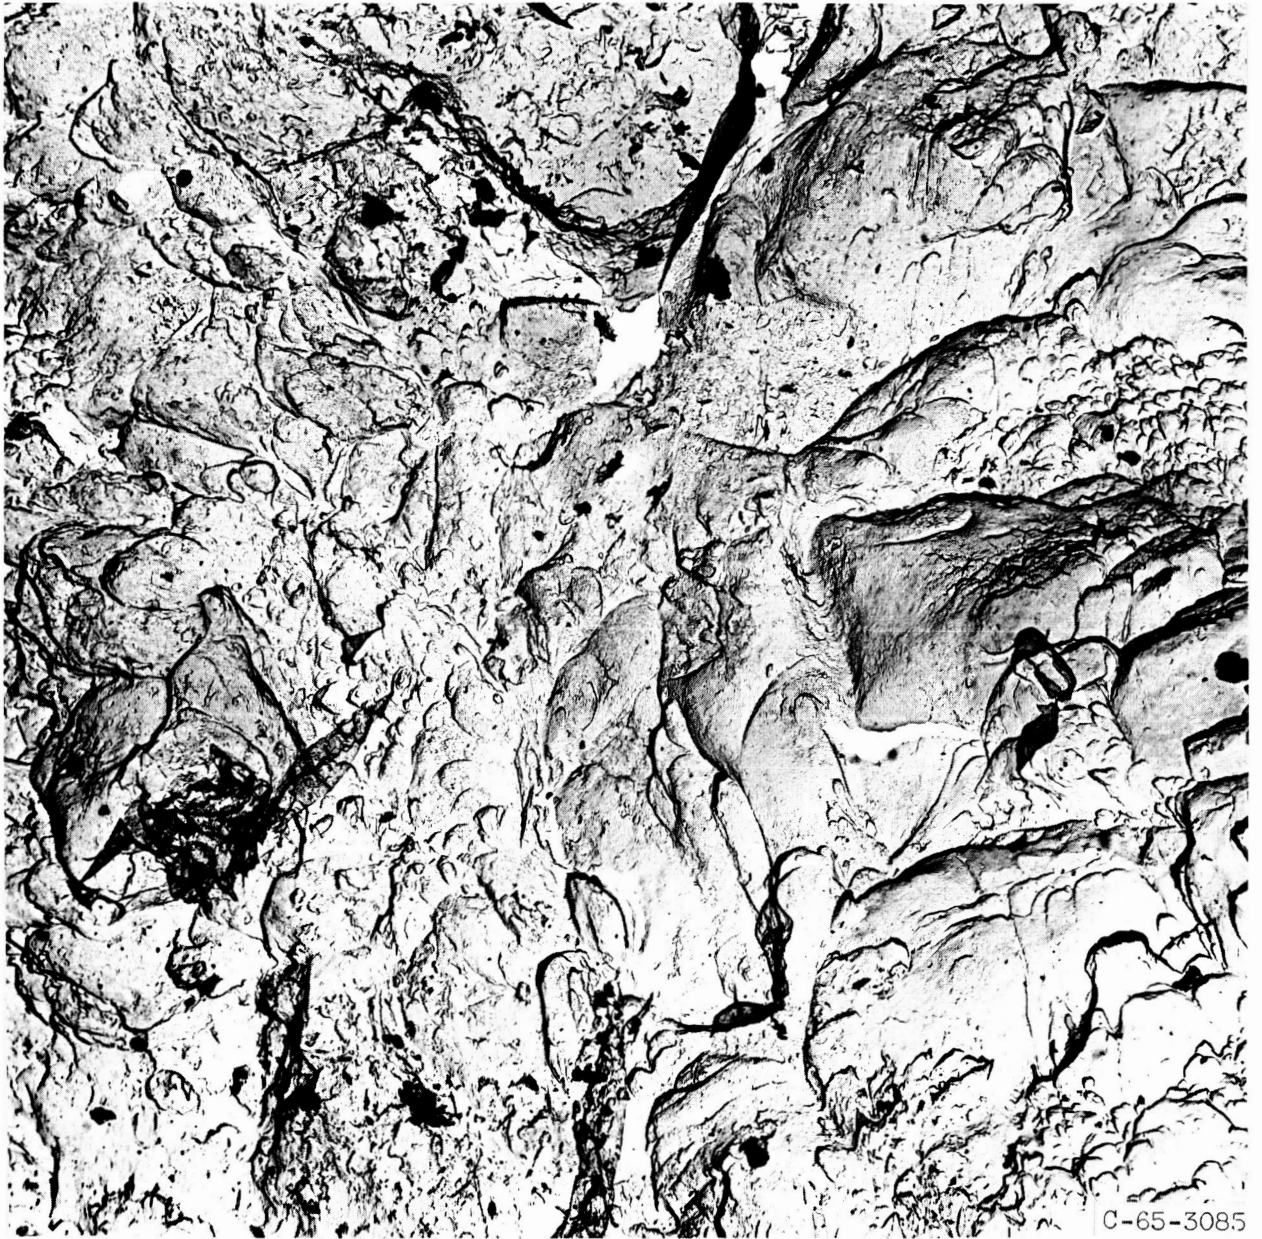
Fractographs of the black-defect surface taken in the various locations, identified as areas 1, 2, 3, 4, and 5 in figure 26, are shown in figure 29. Areas 1 to 3 are located within the black defect itself, and the fractographs (figs. 29(a) to (c)) show a generally flat, intergranular appearance. Various fine-scale surface features are visible in figures 29(a) to (c), but the presence of the black surface film prevents any detailed interpretation. Area 4 (fig. 29(d)), which lies in the subarc weld metal but outside the black defect, exhibits a somewhat more ductile appearance. Area 5 (fig. 29(e)), in a region of the fracture in the base plate outside the black defect, shows a distinctly dimpled contour indicative of ductile fracture.

(a) Area 1 of figure 26.

Figure 29. - Fractograph of black defect. x5000.

(b) Area 2 of figure 26.

(c) Area 3 of figure 26.

(d) Subarc weld - area 4 of figure 26.

(e) Base plate - area 5 of figure 26.
